## LANDSLIDE PROTECTION OF ROADWAY NETWORK DURING THE CONSTRUCTION AND RECONSTRUCTION

We chose to research a section of the Chisinau-Giurgiulesti highway, bypassing the town of Ialoveni. The main objective of the planned studies was to identify the reasons for recurrent deformations of the embankment and the effectiveness of the prescribed landslide prevention works.

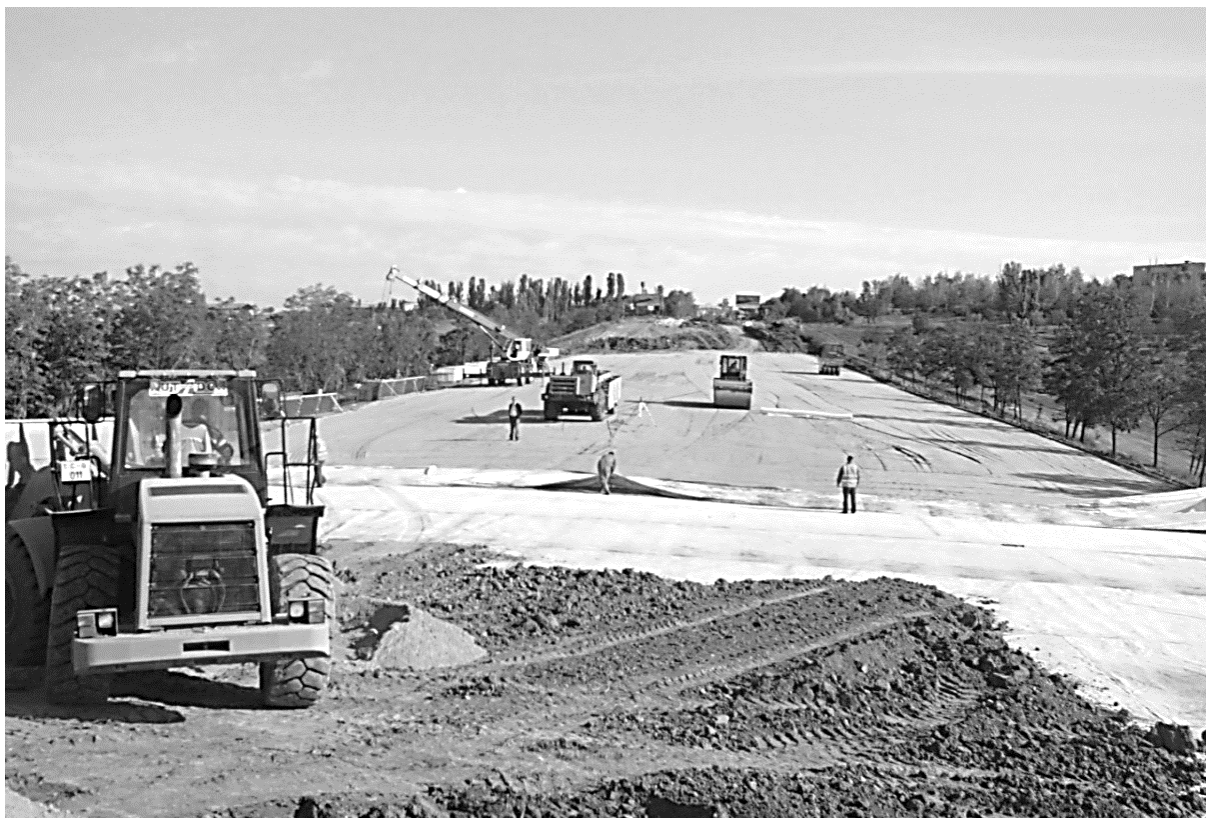
**Figure 1.** Restoration work at a site of embankment bypassing the town of Ialoveni.

- Capping layer soil cut and fill to a depth of 3.0 - 5.0 m;
- Works concerning assurance of impermeability and frost resistance of soils, which compose the road border and located immediately below road topping;
- Works concerning assurance of water disposal and surface water controls;
- Works concerning groundwater flow control (setup of groundwater cutoff);
- Change of slope gradients;
- Reinforcement of ramps through sowing grass, by planting vegetation with an advanced root system, which slows down the advancing of erosional-landslide processes.

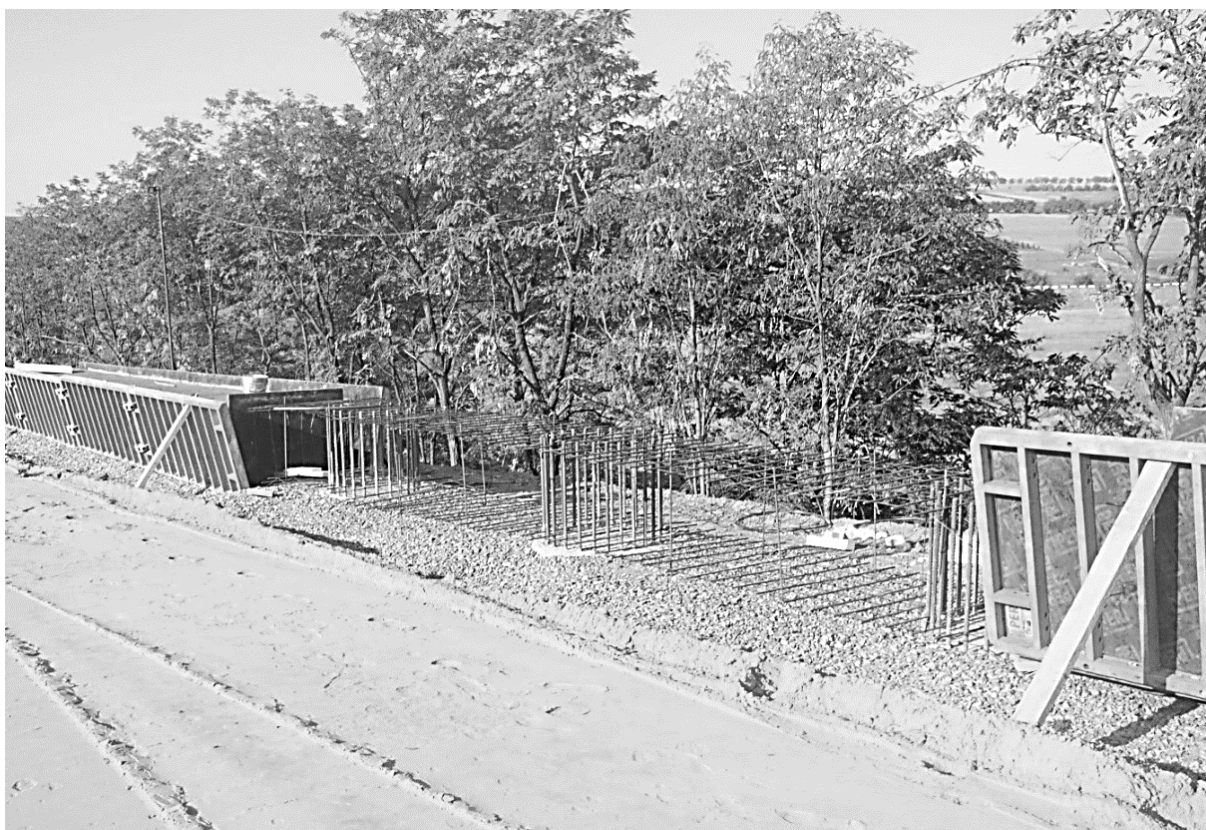
**Figure 2.** Arrangement of bored piles in the right slope of the embankment.

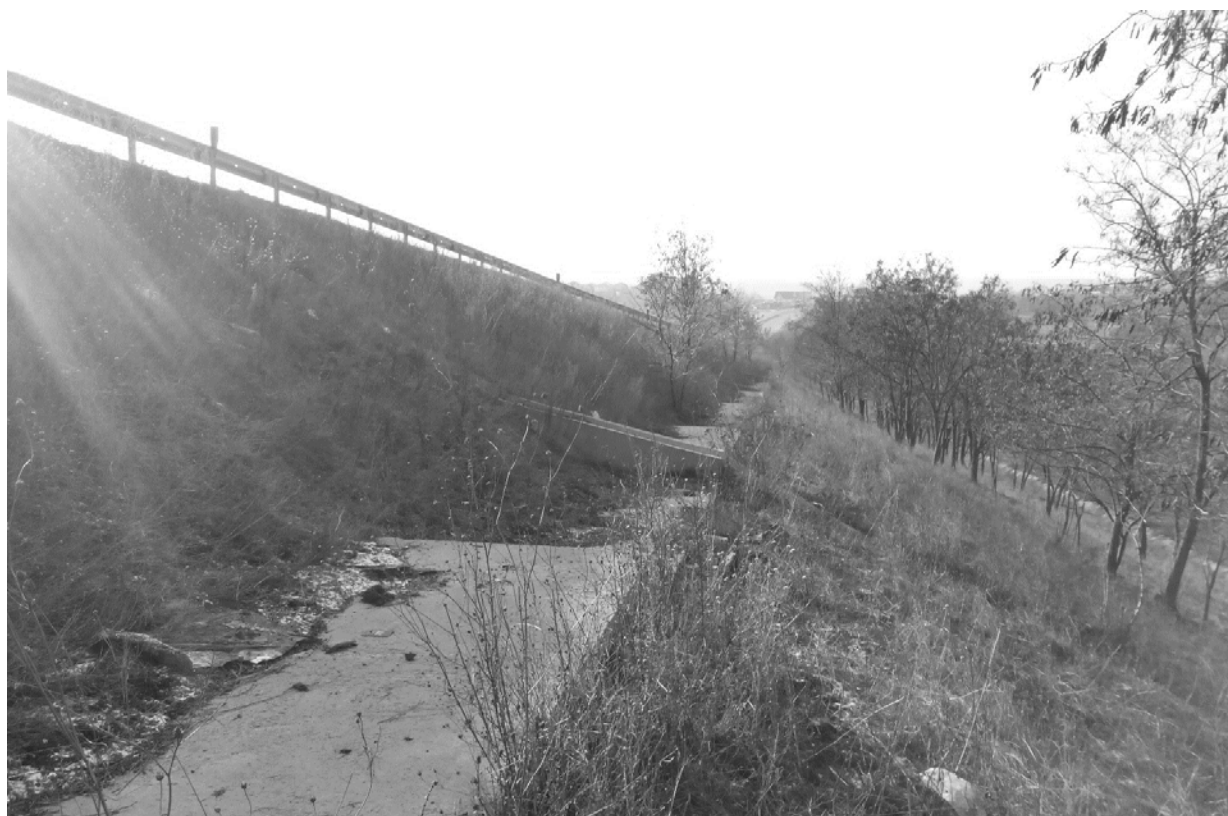
**Figure 3.** Section of embankment in December of 2019.  
*Source: Rascovoi A. from Technical University of Moldova.*

In December of 2019, the authors of this work carried out a visual inspection of the embankment section and performed works. It showed that there are no significant deformations in the mass of the embankment. However, in some spots, in the surfacing, there are longitudinal and transversal cracks opening up to 2 cm wide (Figure 5, 6). The origin of the cracks can be explained by the unfinished consolidation of the newly filled soils and, presumably, by the insufficient rigidity of the road material.

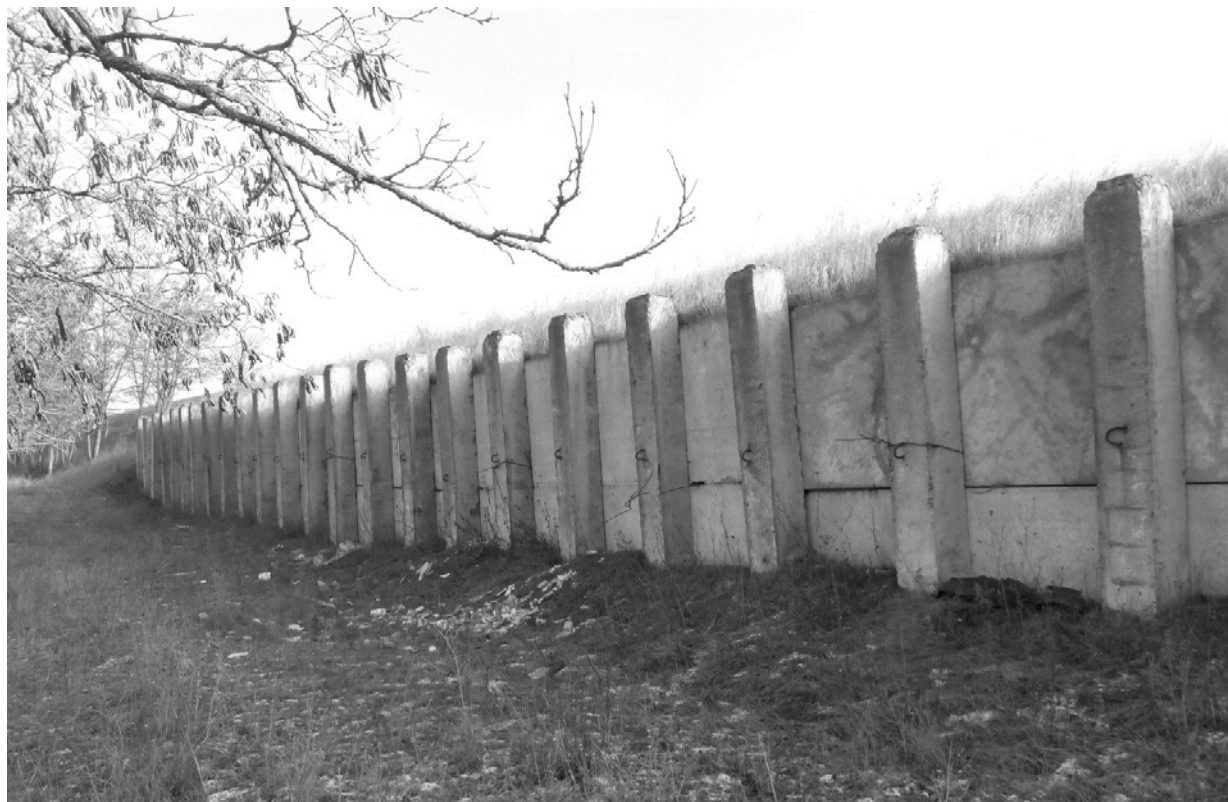
**Figure 4.** Section of embankment in December of 2019.  
*Source: Rascovoi A. from Technical University of Moldova.*

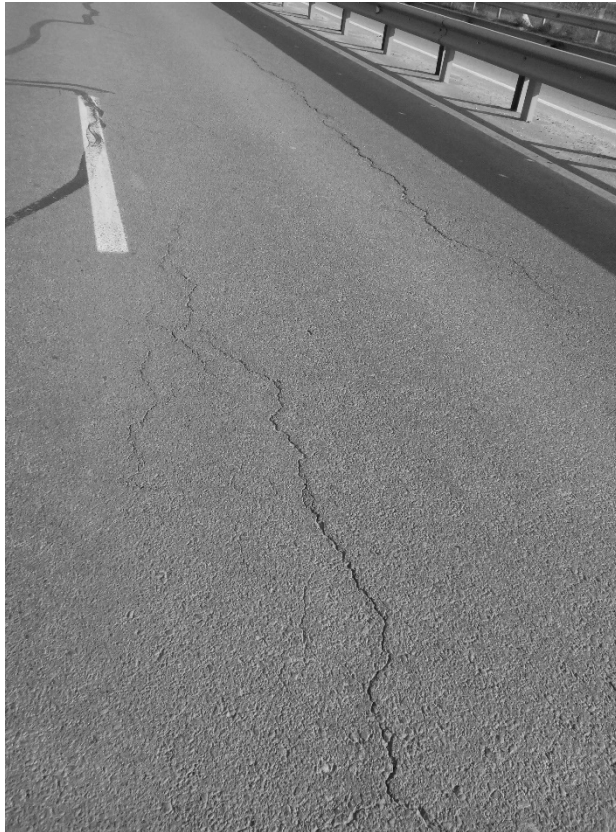
**Figure 5.** Longitudinal cracks in the road surface. December 2019.

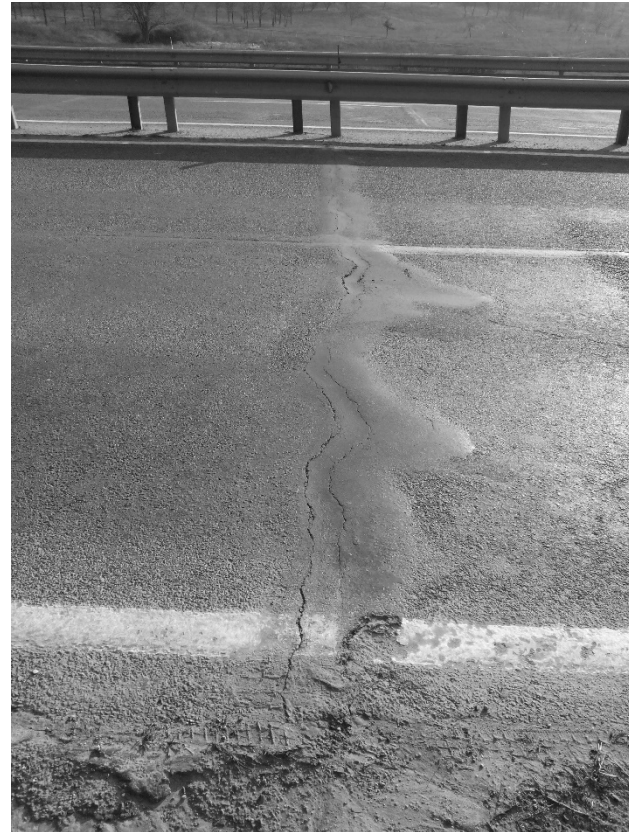
**Figure 6.** Transversal cracks in the road surface. December 2019.
